Investigating Bearing Subsurface Microstructural Damage of White Etching Areas and Butterfly Wing Cracks

Abstract. This paper investigates subsurface microstructural damage of raceways observed in samples cut from two failure wind turbine gearbox bearings. Using optical microscopy and scanning electron microscopy, subsurface crack networks and butterfly wing cracks at non-metallic inclusions are observed. The 3D butterfly damage structure, microstructure and hardness of white etching areas are analysed and evaluated.

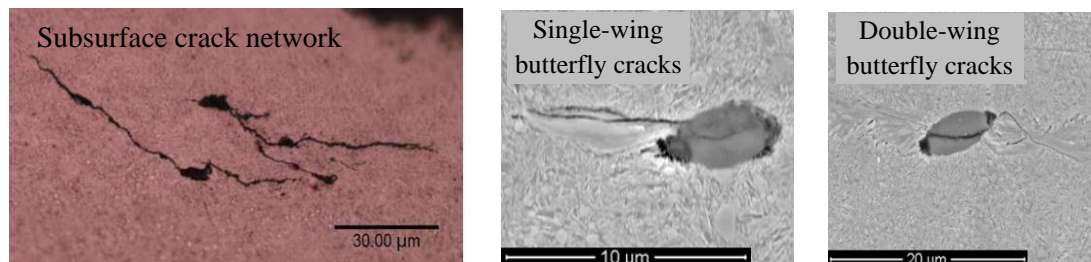
Fig.1. Bearing raceway subsurface crack network and butterfly wing cracks with WEAs

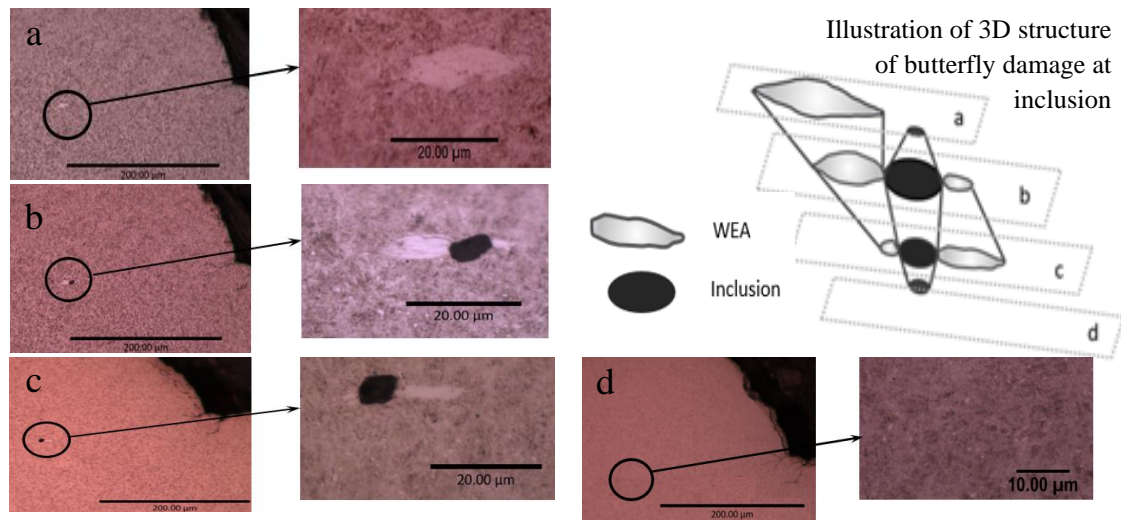
To study the 3D structure of butterfly damage, a sample with a WEA of 20 µm in length is polished and etched four times. As can be seen in Fig.2, after the second polishing/etching, the WEA damage has changed from a single wing, in Section a, to a butterfly with two wings, in Section b. After the third polishing/etching shown in Section c, the length of the left-wing is reduced while the length of the right-wing is increased, probably caused by shape differences of the inclusion in different observing planes. The inclusion geometry and size is determinant for stress concentration thus affecting the size of WEAs. After the fourth polishing/etching, no butterfly damage is found within the steel matrix, as the entire butterfly damage is polished away.

Fig. 2 Four sectional planes, three with 2D butterfly damage (a, b, c); and 3D illustration of the inclusion geometry and associated butterfly wing shapes

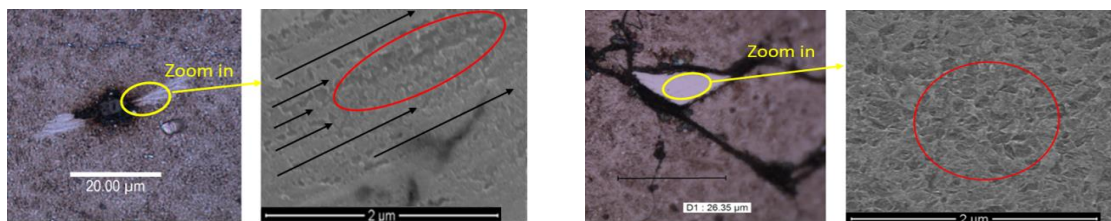
In order to determine whether the microstructure of WEAs in RCF crack networks is different from that in butterfly wings, SEM is used to magnify both types of damage by 60,000 times. Fig.3 shows that both WEAs have dense ferrite structures. The only difference is that the WEA in the crack network does not have the significantly elongated grains like that in the butterfly wing WEA, which may be caused by shear deformation during the formation of the butterfly wing. Based on these observations, it can only be concluded that WEA is composed of a dense ferrite structure, but the cause of its formation could not be confirmed.

Fig. 3 Comparison of WEA microstructure in a butterfly wing (left) with that in a crack network (right)

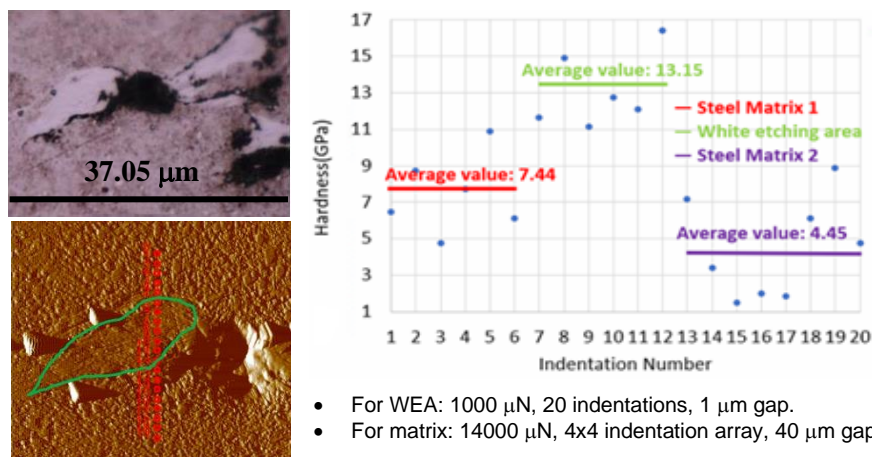
Nano-indentation tests are carried out to measure the hardness of both bearing steel matrix and WEA, and a four-wings butterfly is selected. One test measures the hardness of the 100Cr6 steel matrix and another for the WEA. As shown in Fig.4, the butterfly WEA of an ultra-fine ferrite structure has a much higher average hardness of 13.15 GPa than that of the steel with the martensite structure, accelerating RCF crack propagation.

Fig. 4. Nano-indentation tests for hardness measurements of bearing steel matrix and white etching area
